**MILL CREEK HABITAT RESTORATION AND BANK STABILIZATION,  
TOWN OF RICHMOND, ONTARIO COUNTY, NEW YORK:  
DESIGN REPORT**

**Mill Creek Streambank Stabilization Project  
Town of Richmond, Ontario County NY**

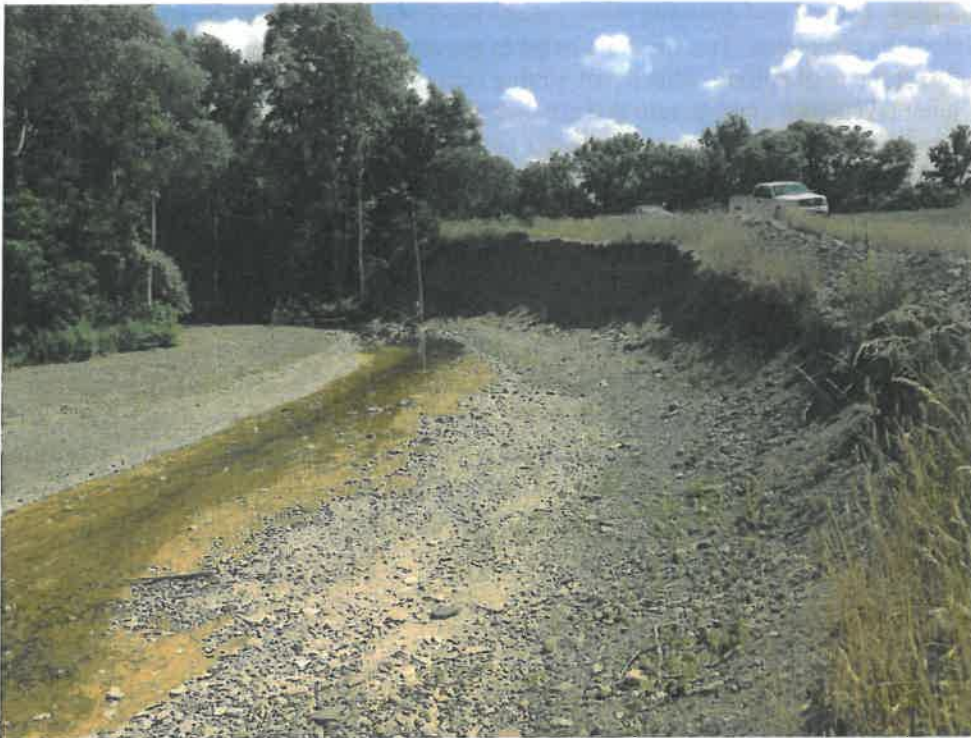
**Figure 1. 7/6/16 View of Mill Creek streambank erosion facing upstream (southeast); eroded area is approximately 20ft in height at easternmost point. The Sandy Park Nature trail runs parallel to the stream, with an earthen berm currently blocking pedestrians from walking too close to eroded bank.**

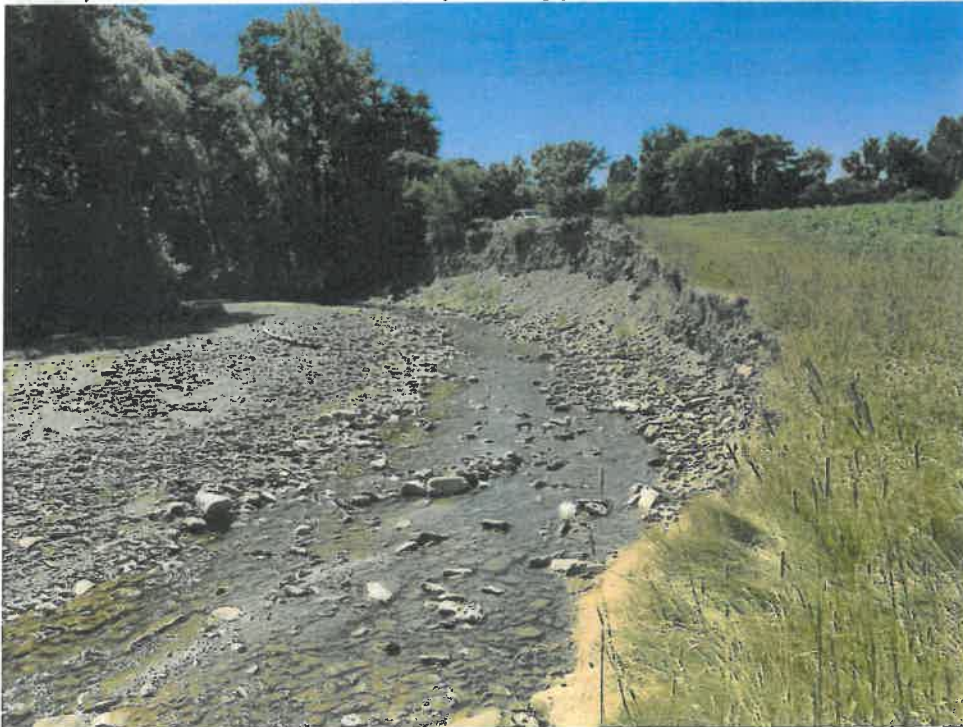
**Figure 2. 7/20/18 View of Mill Creek streambank erosion facing upstream (southeast). Gravel berm placed along edge as seen in Figure 1 has begun to fall into creek bed.**

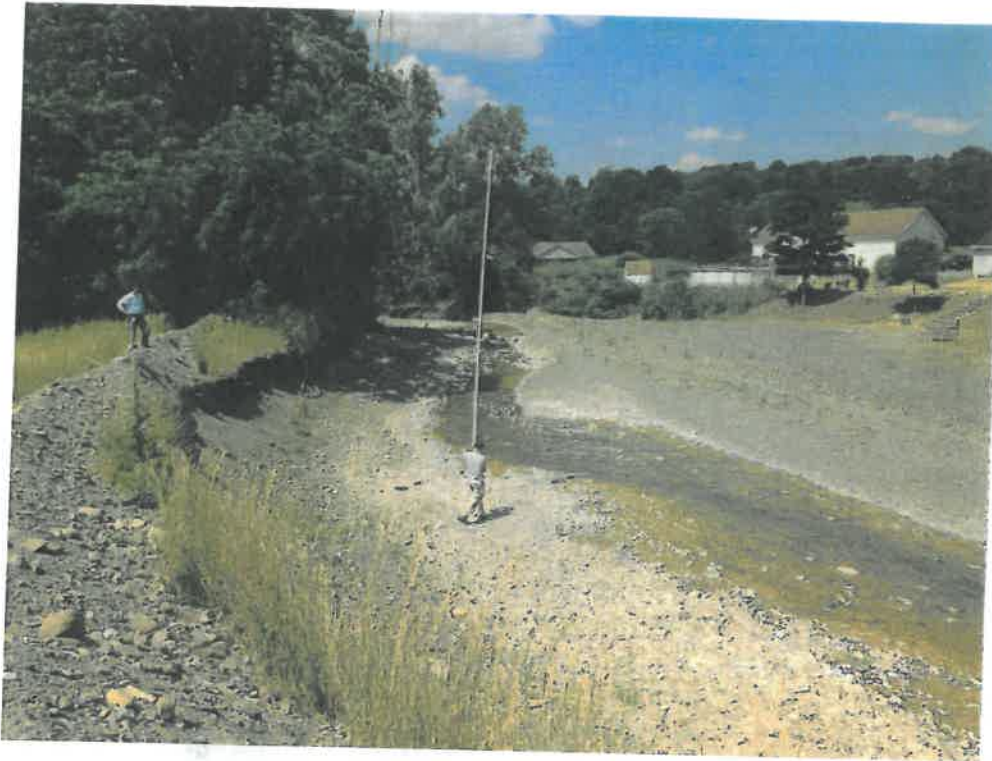
**Figure 3. 7/6/16 View of Mill Creek streambank erosion facing downstream (northwest).**

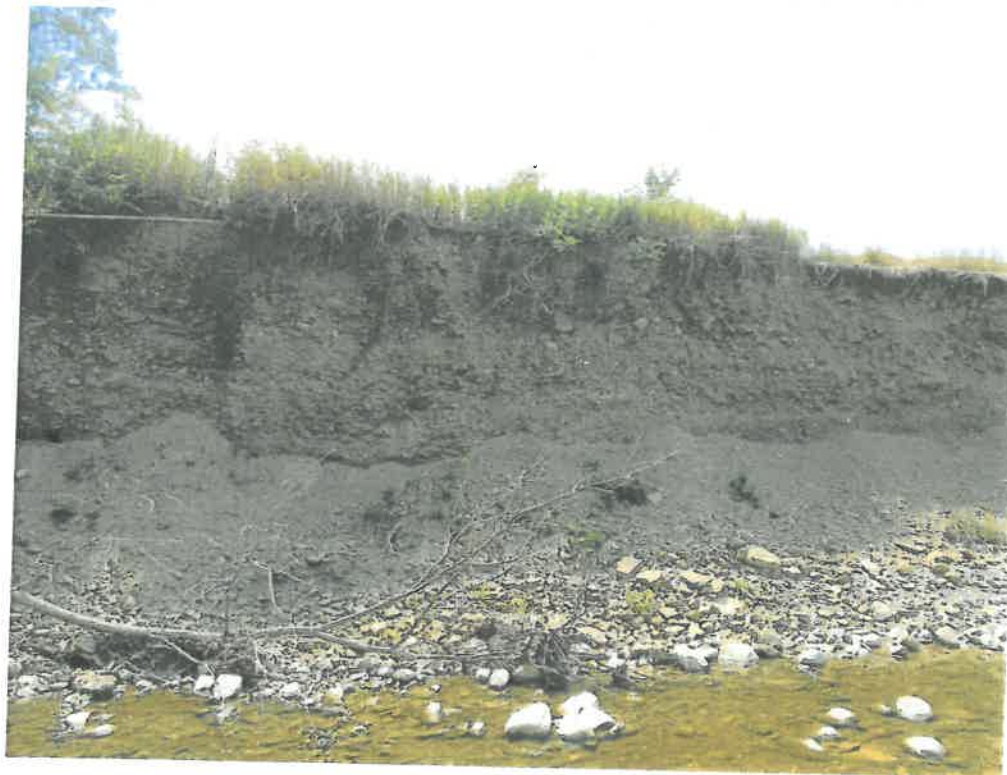
**Figure 4. 7/6/16 View of Mill Creek streambank facing south showing 20ft eroding bank.**

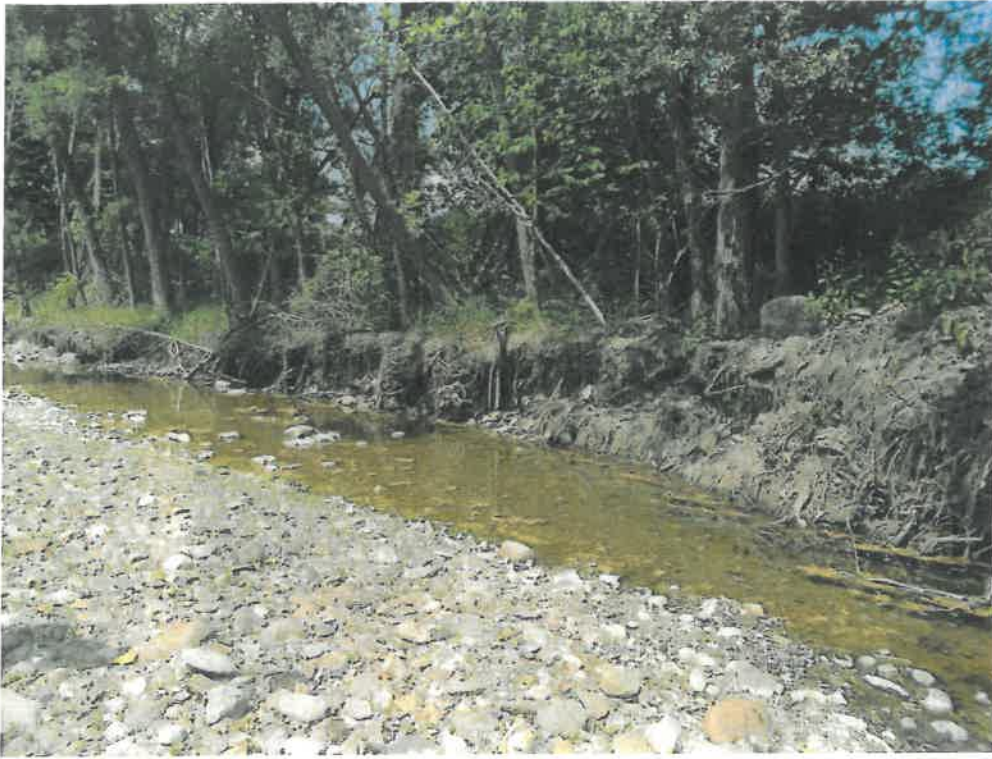
**Figure 5. 7/6/16 View of Mill Creek streambank facing north showing 4-6ft eroding bank.**
